Manhole Inspection Summary

Manhole # S45QQ_003MH

Insp Date: **5/6/08 11:47 AM**

Location Address: **Saint Lo Dr**

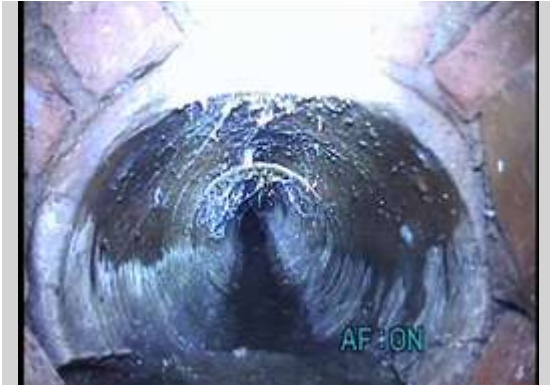
12 O'Clock Outflow

8 in. Circular Gravity Sewer
Pipe Out @ 12 O'Clock

Pipe Height: **8.4** (in.) Rod and Bar (Angled)
Pipe Material: **Clay** ☐ Pipe Lined
Invert Depth: **4.00** (ft.) Flow Characteristics: **Slow**
Deposits: ☒ None ☐ Mud ☐ Sludge ☐ Debris ☐ Grease
Silt Depth: (in.) Deposits Extent:
Infiltration: **Evidence** Pipe Seal Cond: **Roots**

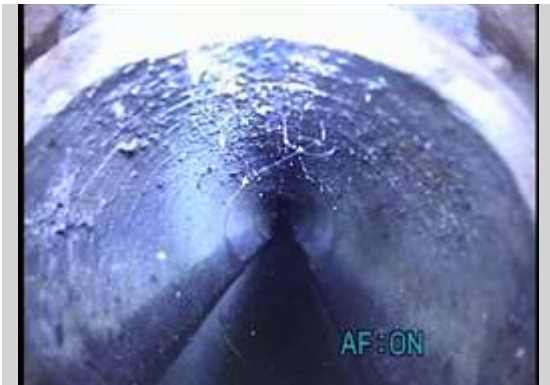
6 O'Clock Inflow

8 in. Circular Gravity Sewer
Pipe In @ 6 O'Clock

Pipe Height: **8.4** (in.) Rod and Bar (Angled)
Pipe Material: **Clay** ☐ Pipe Lined
Invert Depth: **3.70** (ft.) Flow Characteristics: **Slow**
Deposits: ☒ None ☐ Mud ☐ Sludge ☐ Debris ☐ Grease
Silt Depth: (in.) Deposits Extent:
Infiltration: **None** Pipe Seal Cond: **Sound**
